PR24

NORTHUMBRIAN
WATER *living water*

A3-21 ASSET HEALTH INVESTMENT

NES35

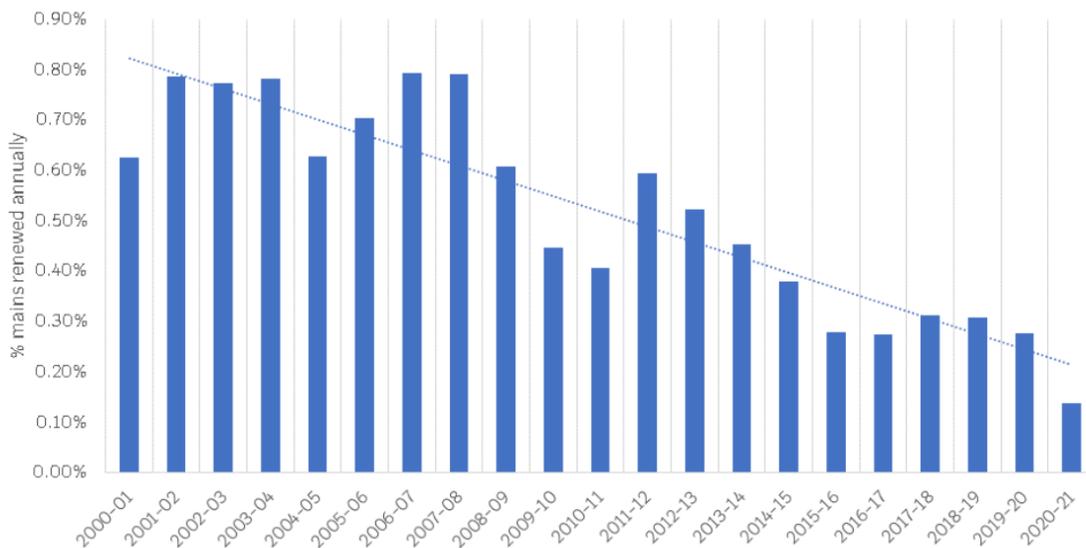
FIGURE 6: ANNUAL MAINS RENEWAL RATES

The analysis also suggests that the larger gaps tend to be in those asset classes with longer lives including water mains and sewer networks whilst investment in more critical water treatment works and sludge treatment works are currently consistent with or slightly above the mid-point values implied by the replacement rate analysis. This is consistent with what we see internally through our management and governance of capital expenditure where scarce capital investment is consistently allocated to more critical asset classes and activities and longer-life assets receive less funding. At an industry level Ofwat has also presented similar information, for example in relation to mains renewal where they showed that industry wide rates of mains renewal had been falling over time.

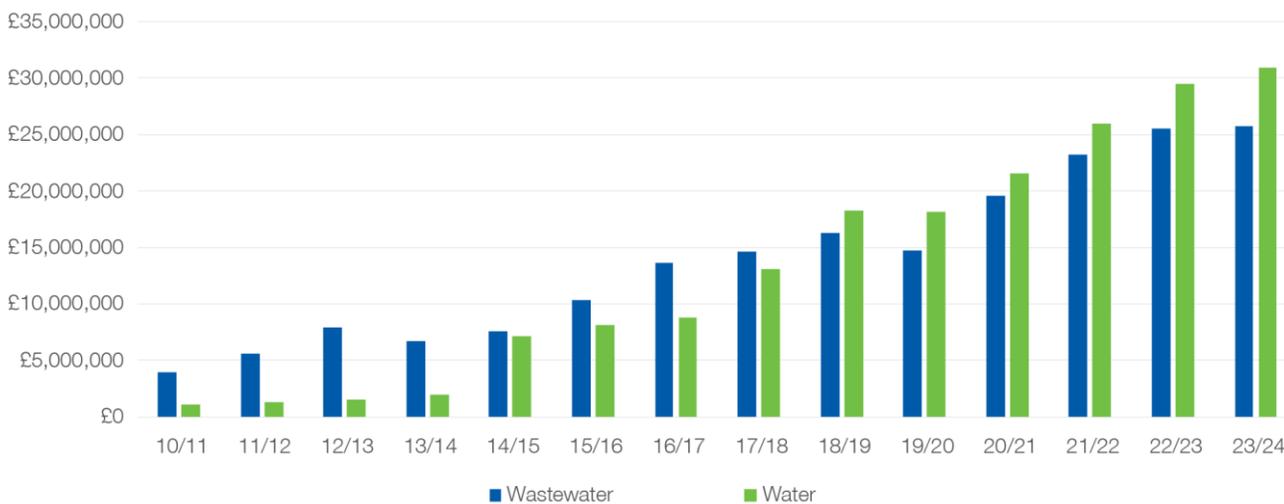
FIGURE 9: NWL REACTIVE MAINTENANCE EXPENDITURE OVER TIME

Wherever possible, we seek to plan future expenditure and maintenance activities by ‘proactively’ identifying investment priorities across the business. This helps us to better manage asset health risks and also often means more efficient costs, because it is often cheaper to proactively maintain and manage an asset than ‘reactively’ fix it when it fails. We monitor reactive maintenance expenditure across the business and over time we have seen substantial growth in this activity. Figure below shows that over time, our reactive maintenance activity has been consistently increasing across both the water and wastewater services.

Source: NWL analysis of historical capital investment data

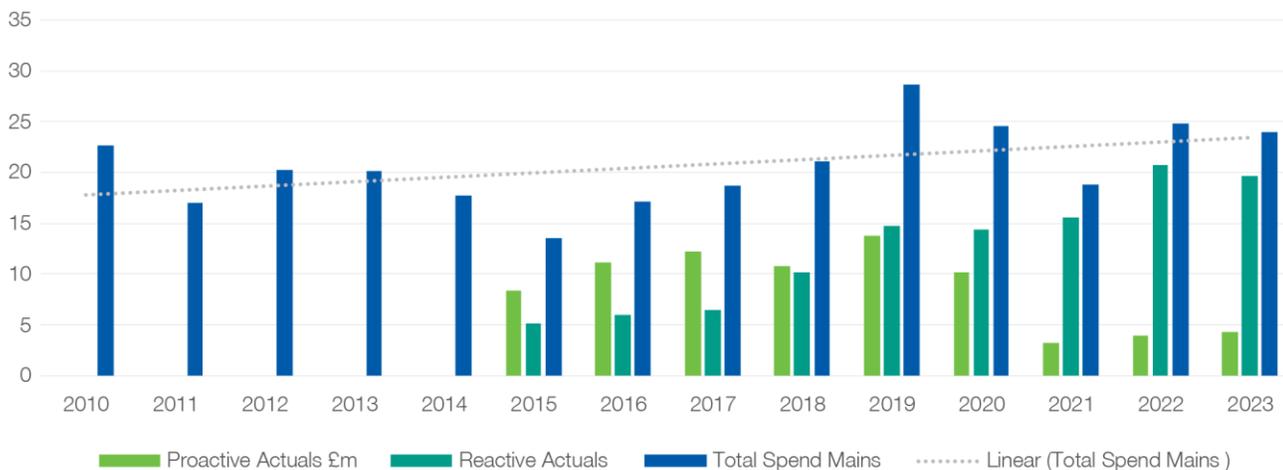
FIGURE 10: ANNUAL EXPENDITURE ON MAINS RENEWALS (£M'S) SPLIT ACCORDING TO REACTIVE AND PROACTIVE RENEWALS

For example, we can observe this move away from proactive to reactive activity in our water mains, which have some of the longest assumed asset lives of all the asset groups we manage (of around 100 years). Since completing the extensive AMP3/AMP4 S19 quality mains renewal programme, our overall expenditure on mains renewal has been relatively stable, as shown in Figure . This clearly demonstrates that our level of reactive spend is increasing at a higher rate than our overall level of mains expenditure, and if the upward trend in reactive spend continues, it will surpass the trend in our overall level of investment in mains renewal within AMP8. This helps to illustrate the immediacy of the problem we face and the need to increase investment in AMP8.

Since the completion of the extensive AMP3/AMP4 S19 quality mains renewal programme, our overall expenditure on mains renewal has been relatively stable, as shown in Figure 10. This clearly demonstrates that our level of reactive spend is increasing at a higher rate than our overall level of mains expenditure, and if the upward trend in reactive spend continues, it will surpass the trend in our overall level of investment in mains renewal within AMP8. This helps to illustrate the immediacy of the problem we face and the need to increase investment in AMP8.

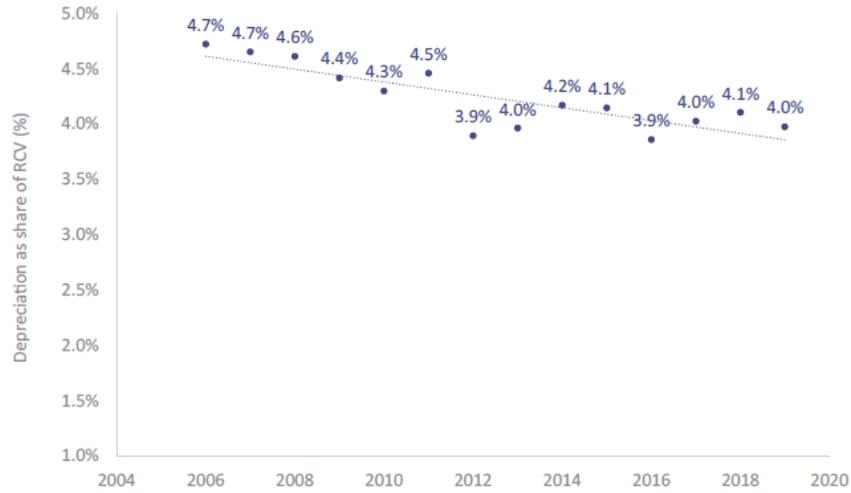
FIGURE 11: INDUSTRY DEPRECIATION RATE ON WATER ASSETS, 2006-2019

- The data for depreciation of water and wastewater assets from 2004 to 2020 overall shows a downward trend in the depreciation rates. For water assets, this decreased from 4.7% in 2006 to 4.0% in 2019 (a 15% decline); and for wastewater assets it decreased from 4.8% in 2006 to 3.6% in 2019. This implies that we are collectively expecting the assets to last longer on average.

Notes: Economic Insight analysis of 2006-2019 Annual Performance Reports. The depreciation rate has been calculated using the 'Depreciation Charge for year' for 'Water Service' divided by the 'Average RCV' for water assets for the year. The average RCV for water assets is calculated using the average RCV split between water and wastewater assets reported for PR14. The depreciation rate for the industry has been calculated using the aggregate 'Depreciation Charge for year' and the 'Average RCV' across the industry.

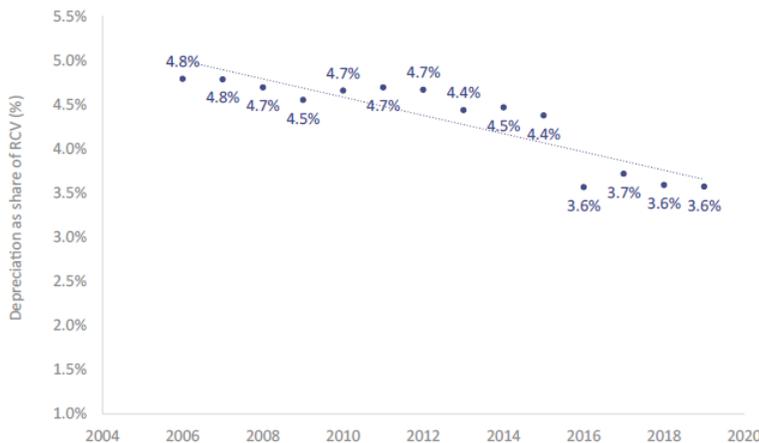
FIGURE 12: INDUSTRY DEPRECIATION RATE ON WATER ASSETS, 2006-2019

Notes: Economic Insight analysis of 2006-2019 Annual Performance Reports. The depreciation rate has been calculated using the 'Depreciation Charge for year' for 'Wastewater' divided by the 'Average RCV' for wastewater assets for the year. The average RCV for wastewater assets is calculated using the average RCV split between water and wastewater assets reported for PR14. The depreciation rate for the industry has been calculated using the aggregate 'Depreciation Charge for year' and the 'Average RCV' across the industry.

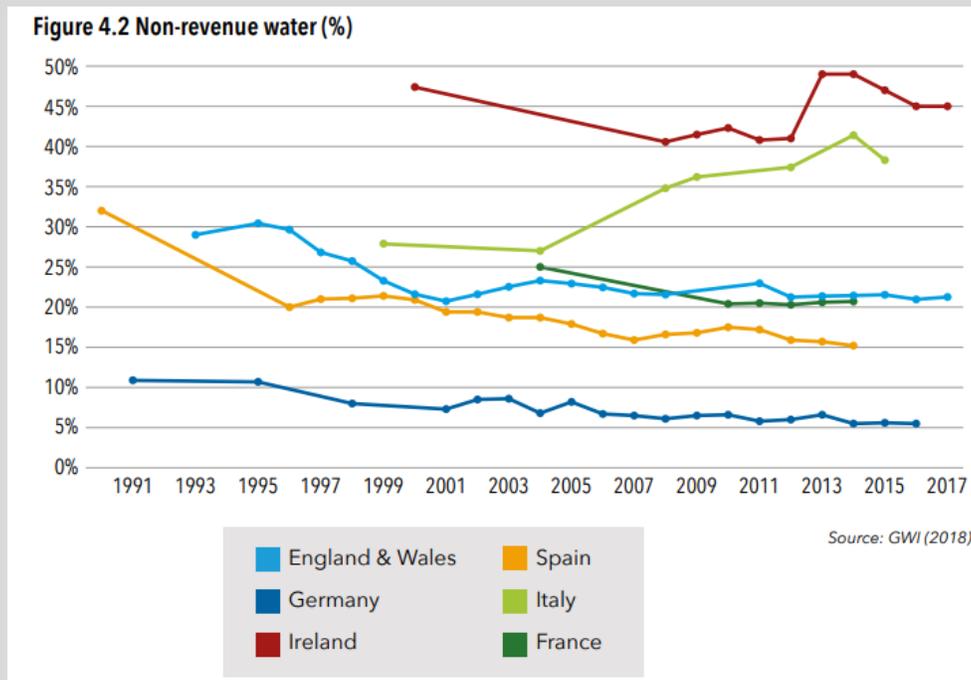
FIGURE 13: NON-REVENUE WATER COMPARISONS ACROSS EUROPE

The [Global Water Intelligence \(GWI\) market study](#) in 2018 looked at the percentage of non-revenue water compared to total distribution input. The England and Wales data is believed to include supply pipe leakage (as this is usual practice) and hence this is not a true comparator. That said, England and Wales are similar to France, with Ireland being significantly higher and Germany being at 5%. Germany has invested significantly in its network over the past 70 years and is also assisted by benign soils and favourable water chemistry when compared with the UK.¹²

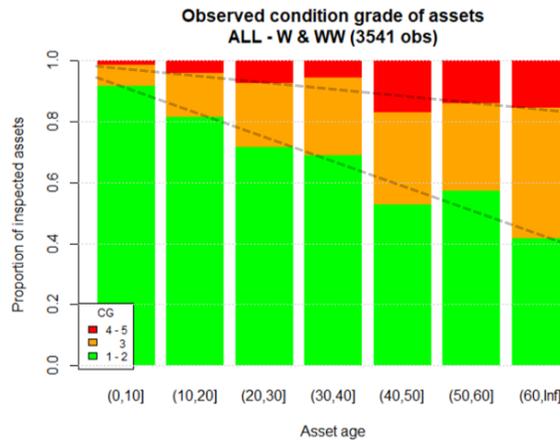
FIGURE 22: DISTRIBUTION OF ASSET CONDITION FOR ALL TANKS

Figure 22 shows our analysis of all 3,541 inspections, as the proportion of assets in each condition grade split into 10-year bands. The older the asset, the worse the condition grade; and the proportion of assets in condition grade 3 and worse increases to about 40% after 60 years. This includes about 15% in grades 4 and 5.

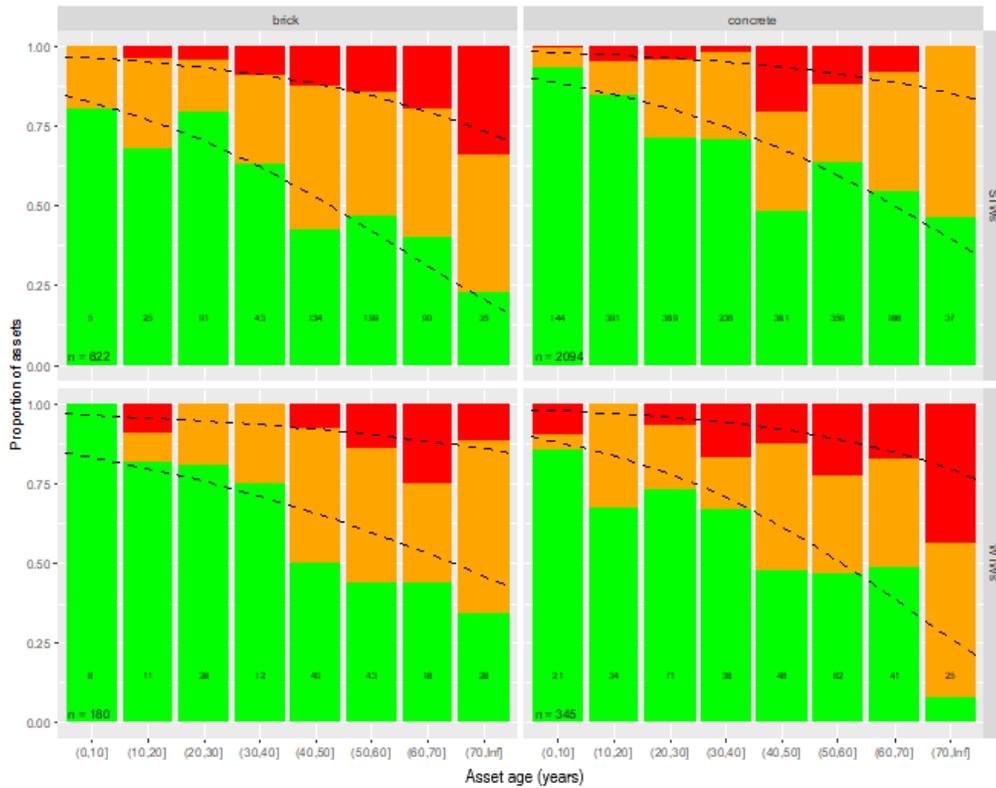
FIGURE 23: DISTRIBUTION OF ASSET CONDITION BY MATERIAL AND USAGE

The following four graphs show the same information broken down by material (brick and concrete) and usage (water and wastewater) and the sample size for each group. The results provide useful additional data which will help to target further surveys and investigations into specific asset groups as part of detailed engineering design as needed.

The general conclusions from a visual inspection of asset condition is that the results are a good representation of observed condition distributions for specific groups of assets.

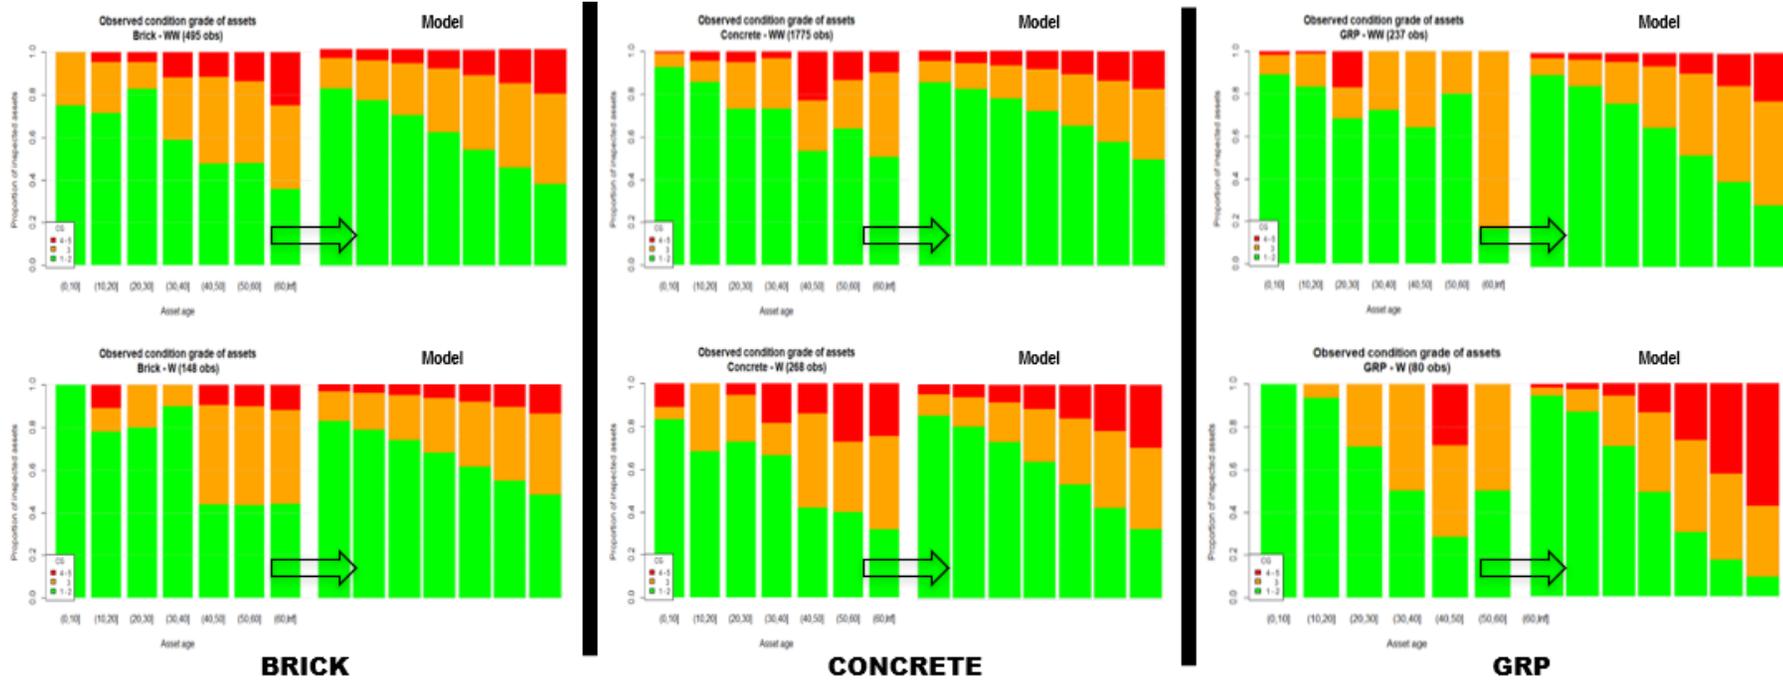
FIGURE 24: COMPARISON OF ACTUAL AND MODELLED DISTRIBUTION OF ASSET CONDITION

We validated the statistical model by using it to recreate the observed condition distribution based on asset inspections. The results are shown below as six pairs of graphs with the observed distribution based on inspection data on the left, and the calculated distribution based on model outputs on the right.

The fit of the survival model to the observed data is satisfactory: all parameters (age, material and usage) are significant, although some groups are harder to compare due to the low number of assets.

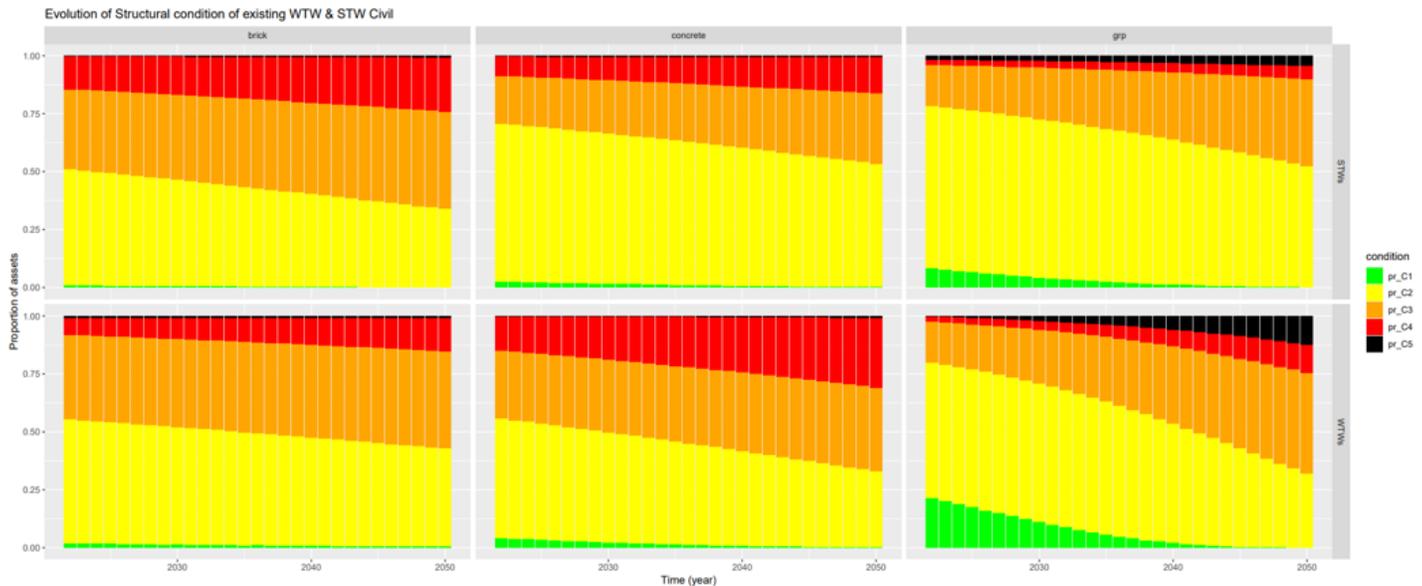
FIGURE 25: FORECAST DETERIORATION OF CIVILS TANKS BY USAGE AND MATERIAL

We used the validated statistical model to generate the information in the following graphs (from Figure 25 onwards) which forecast deterioration in the condition of WWTW (brick, concrete and GRP) and WTW (brick, concrete and GRP) between 2022 and 2050.

This shows a movement of civils structures through the condition grades towards grades 3, 4 and 5, as we would expect. The rate of change varies according to usage (WWTW or WTW) and material with a noticeable movement towards grades 4 and 5 for GRP tanks (which is to be expected because GRP tanks have a lower design life).

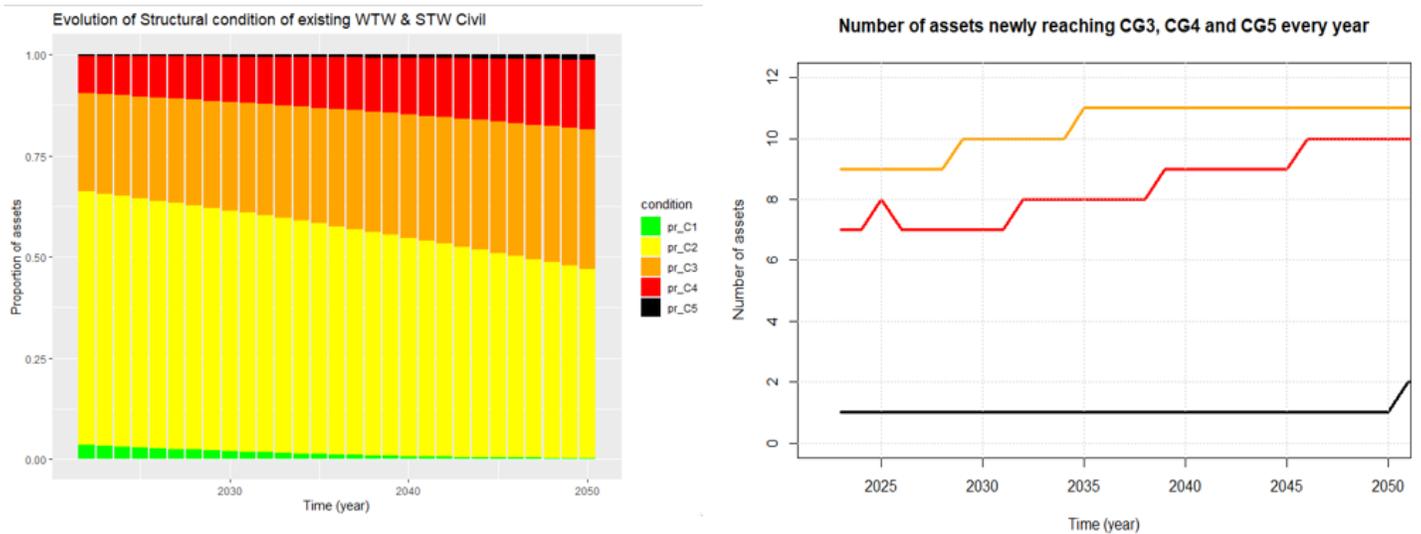
FIGURE 26: FORECAST DETERIORATION OF CIVILS TANKS

We also used the model to generate the information below which forecasts the number of civils tanks moving from condition grades 2, 3 and 4 into grades 3, 4 and 5 between 2022 and 2050. This analysis is for WTW and WWTW combined and all materials.

The results show that every year for the next six years there will typically be:

- One asset reaching condition grade 5.
- Seven assets reaching grade 4.
- Nine assets reaching grade 3.

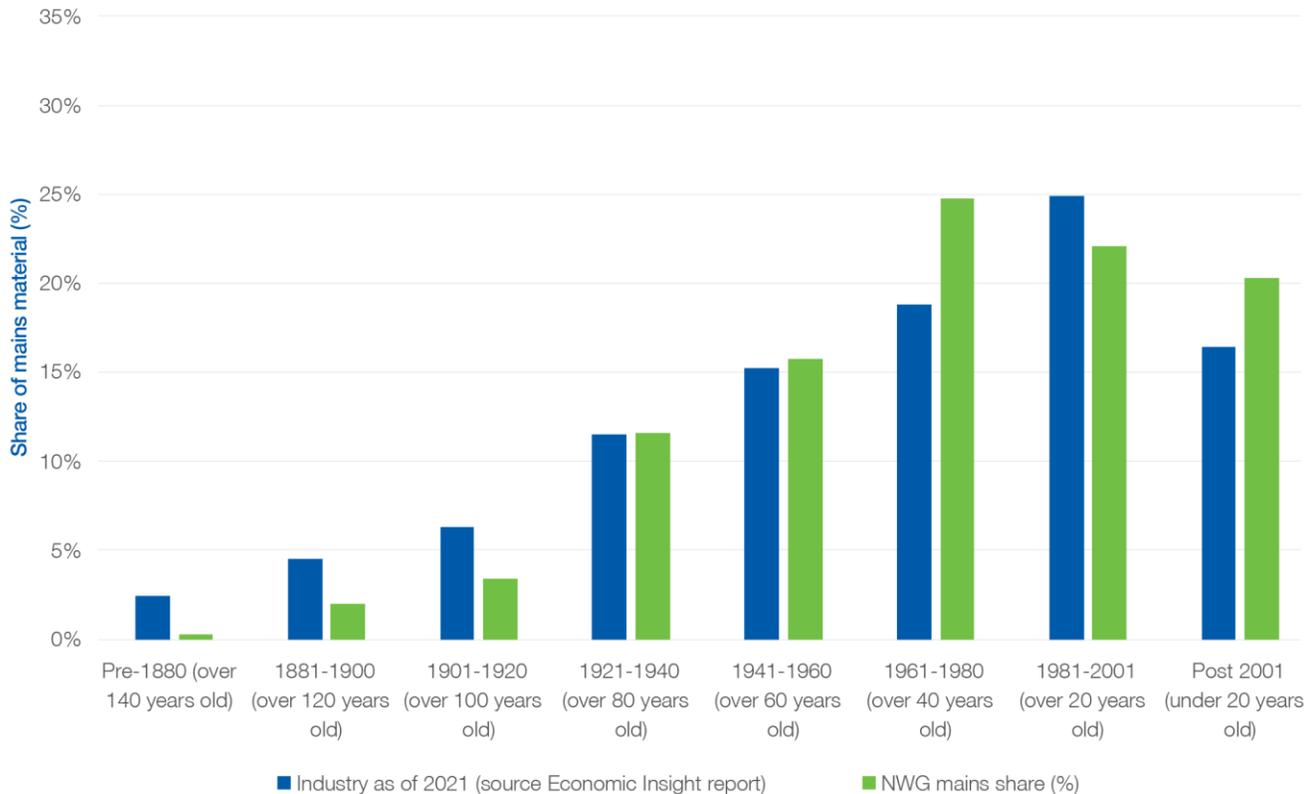
FIGURE 275: OUR MAINS AGE COHORTS COMPARED TO INDUSTRY AVERAGE, SHARE OF MAINS (%)

Most mains we lay now are polyethylene (PE) which has been found to be a stable material and is currently meeting expectations of a long asset life, as described in section 4.5.3.

Source: NWL asset intelligence data

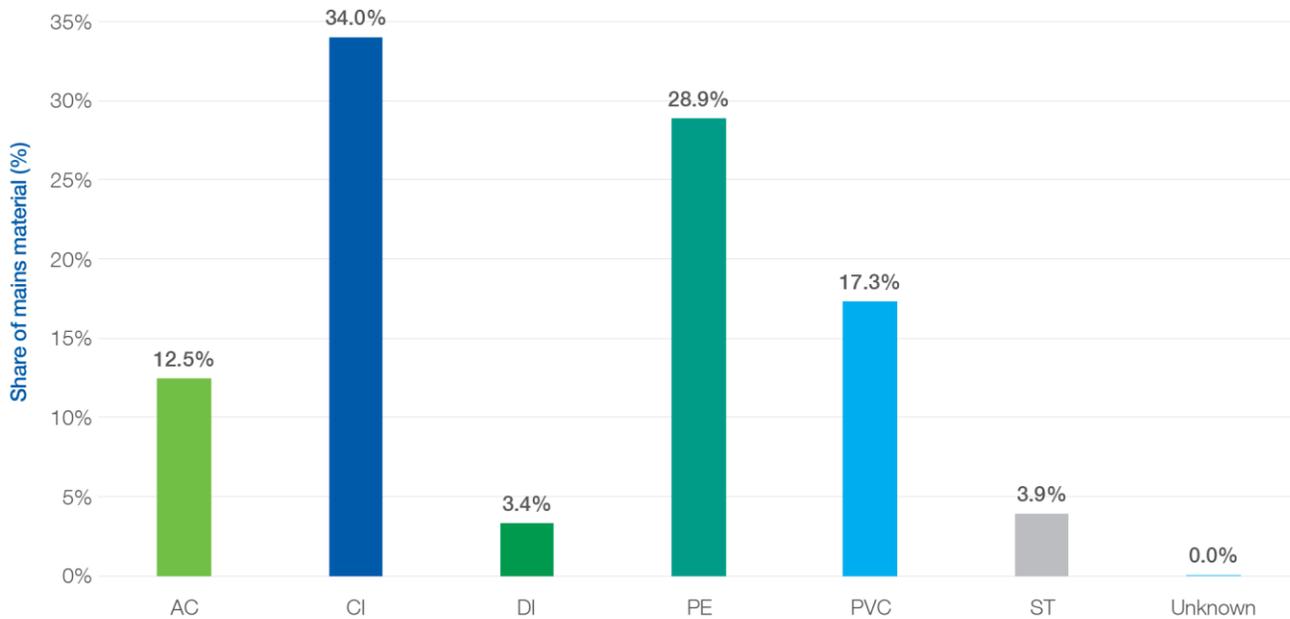
FIGURE 28: PIPE MATERIALS IN OUR MAINS

In addition, in aggressive or clay soils, which can be found in all our regions, CI represents the most significant burst risk. Climate change modelling tells us this risk is increasing the likelihood of dry summers which put further pressure on mains laid in the soils in our areas. Figure 28 shows how, despite the large mains replacement programme undertaken in the 1990s and 2000s, CI is still the most common material in our network by length, emphasising the significance of the risk that deterioration in CI represents to our mains performance.

Source: NWL asset intelligence

Our PVC mains represent the next most significant overall burst risk to CI at the company level. Many of the mains laid between 1961 and 1980 are PVC, with it being considered the best modern material at the time. PVC has been found to age quickly, becoming brittle which leads to increasing burst rates. It therefore has a shorter asset life than CI or PE. Significant proportions of our northern and Suffolk pipes are PVC, but not such a high proportion in Essex.

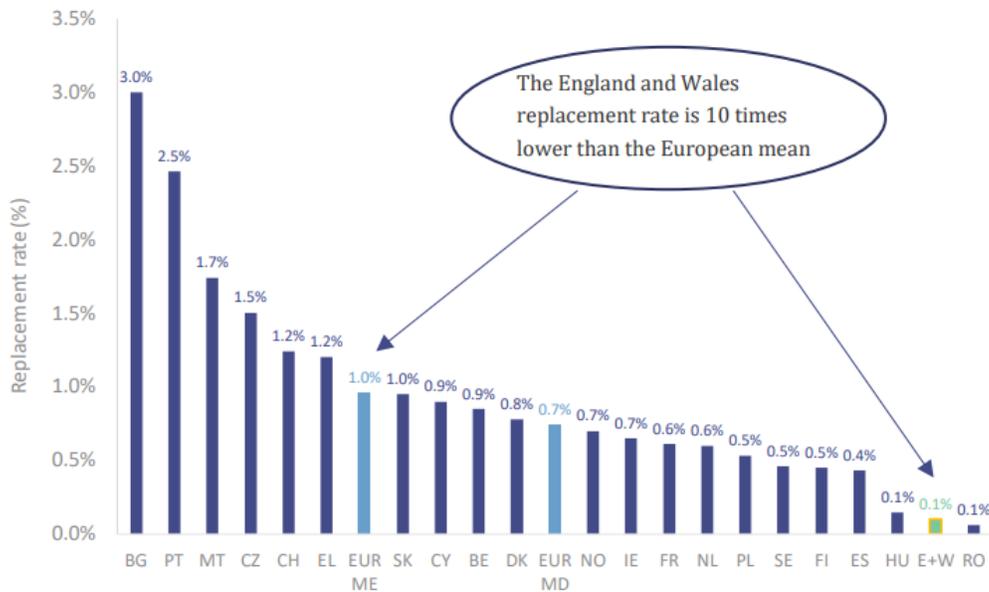
FIGURE 29: MAINS REPLACEMENT RATES IN EUROPE

In England and Wales, we are replacing mains at a lower rate than almost all European countries, and well below the European mean (see Figure 29 taken from the [Economic Insight report provided for Water UK](#)). This would be the case even for Ofwat’s assumption at PR19 that companies could renew 0.4% of mains per year.

Sources: Economic Insight analysis of the following data sources: (i) ‘Europe’s Water in Figures.’ EurEau (2021); and (ii) 2021 Annual Performance Reports.

Notes: The renewal rate of water assets for England and Wales is calculated as the ‘Total length of potable mains renewed’ in 2020-21 divided by the ‘Total length of potable mains’ at the start of the 2020-21 reporting year. European data relates to average asset renewal rate for drinking water infrastructure for periods 2017-2019 (depending on the country), while the data for England and Wales relates to 2021.

Figure 29 shows data from 2021 for England and Wales. Even if we look over a longer period, we still see rates well below the European average. For example, over the last 5 years (2018/19 to 2022/23) we observe mains replacement rates of 0.17% which is still less than a fifth of the rates seen elsewhere in Europe, and still imply an implausibly high implied asset life of almost 590 years. Although not conclusive, this evidence points to different practices elsewhere in Europe.

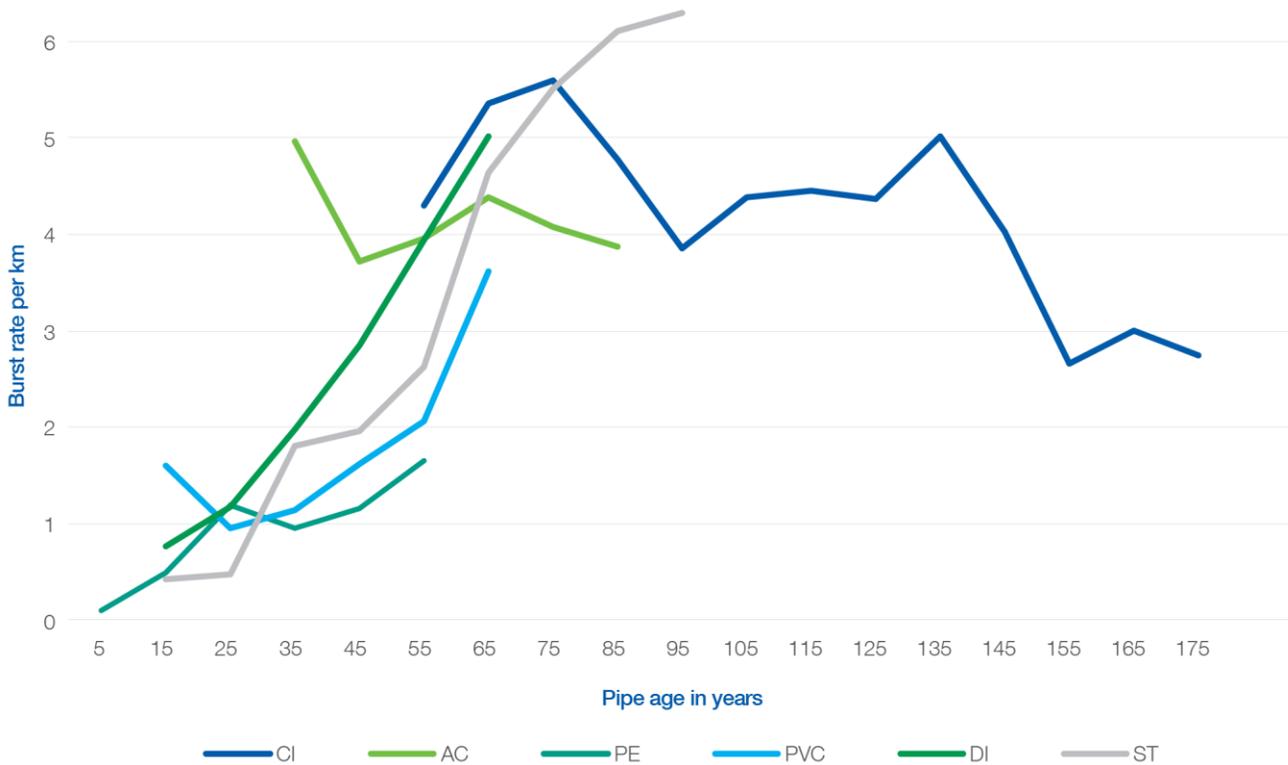
FIGURE 30: WATER SUPPLY PIPELINE MATERIAL AND BURST RATE PER KM VS PIPE AGE IN YEARS

Figure 30 shows the materials of our complete water supply network which includes larger trunk mains and distribution mains. It shows there are increasing burst rates as materials age, but that some materials are seeing higher burst rates than others at the same age. It also indicates that our current material of choice for mains replacement and new mains, PE, is aging well. The rate of increase in bursts per km for PE is lower than the other materials. However, the chart also shows that as more of our pipes reach an age greater than 40 years, without a significant replacement programme we can expect burst rates to increase.

Notes: CI = cast iron; AC = asbestos cement; PE = polyethylene; PVC = polyvinyl chloride; DI – ductile iron; ST = steel

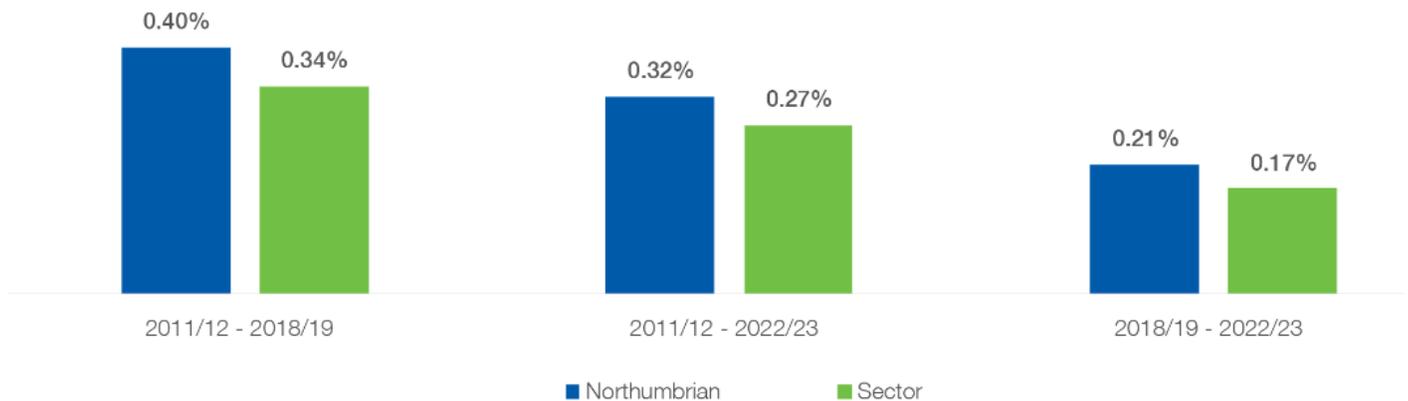
FIGURE 32: AVERAGE ANNUAL MAINS RENEWAL RATES

We agree that the limited lagging asset health metrics that we observe and target across the sector have generally improved and not deteriorated but we do not believe the level of totex allowance has been adequate to undertake the 0.4% levels of mains replacements across the sector. Figure 32 shows the average renewal rates covering three different historic periods:

1. **The PR19 period**, 2011/12 – 2018/19. The average renewal rate obtained from this period covers the econometric modelling period used at PR19 by Ofwat.
2. **The full sample period**, 2011/12 – 2022/23. This period includes data that have been received since PR19. It is the likely data that would be used by Ofwat in the econometric modelling at PR24.
3. **The efficiency period**, 2018/19 – 2022/23. This period covers the last 5 years only. Consistent with Ofwat’s PR19 methodology, we assume efficient allowances at PR24 would also be set based on this period.

The sector-wide average levels of mains renewals over the three periods are significantly lower than 0.4%. This indicates that the implicit allowance companies obtain from the models to renew their mains are lower than what Ofwat assumes companies were funded for at PR19.

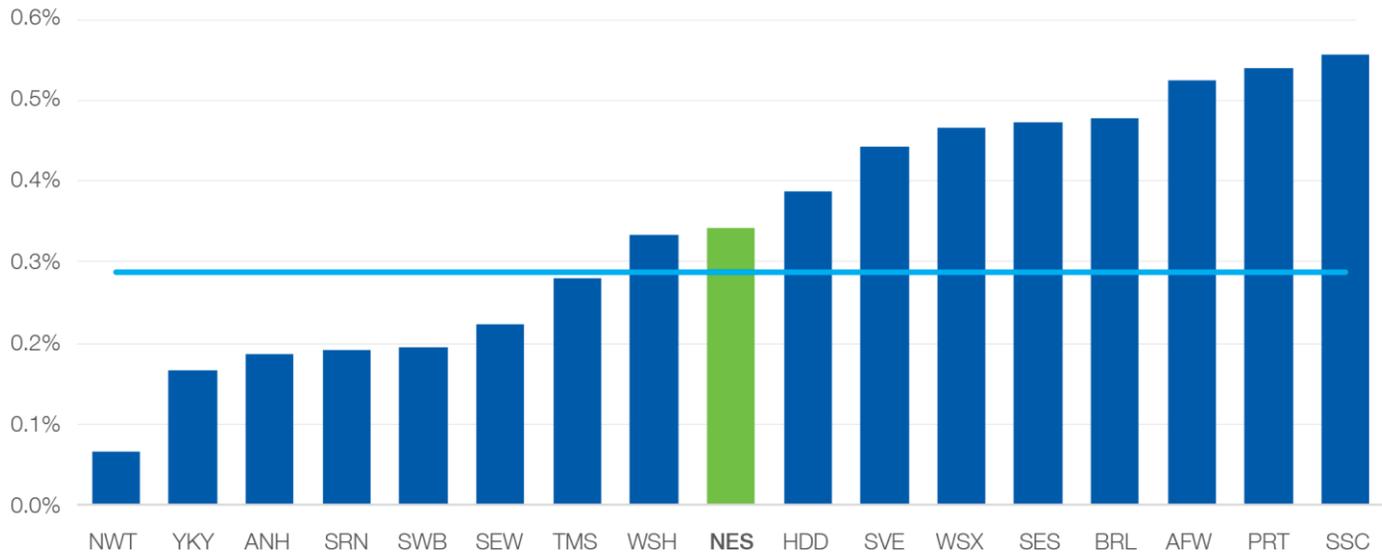
FIGURE 33 ANNUAL AVERAGE RENEWAL RATES OVER THE PERIOD, 2011/12 - 2021/22

Expenditure on Treated Water Distribution infrastructure – maintaining the long-term capability of the assets and the renewals expensed in the year was used to capture the costs associated with mains renewals.

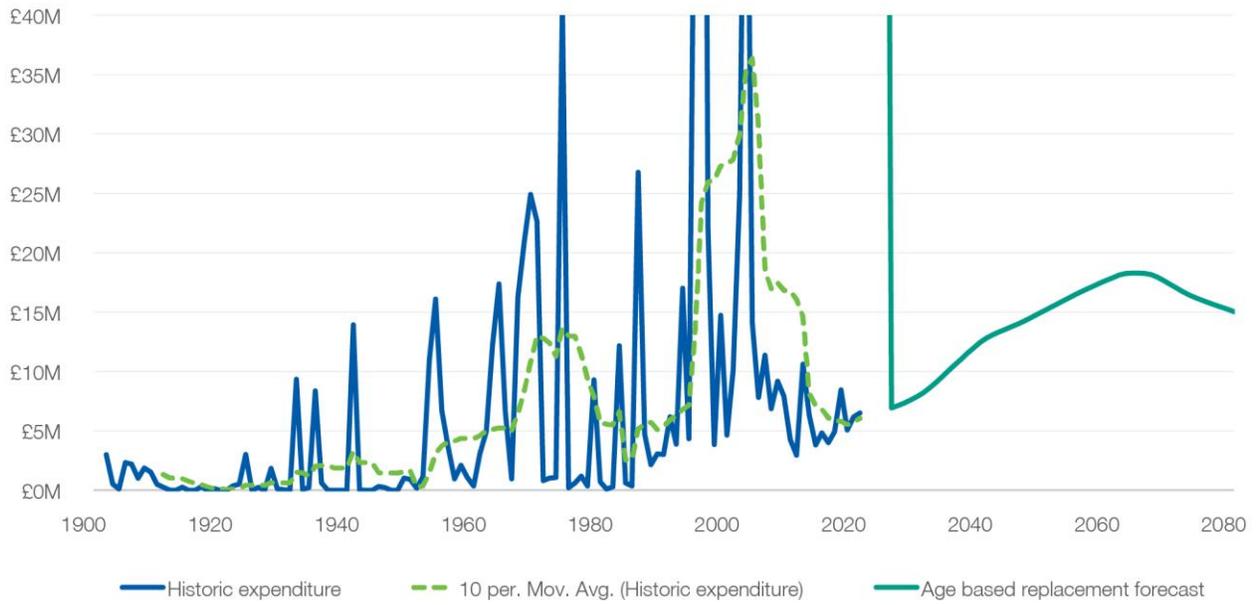
FIGURE 38: HISTORIC PROCESS CIVIL EXPENDITURE AT WTWS WITH FORECAST AGE BASED REPLACEMENT

The FAR analysis does show a historical record of expenditure on the base civil process assets at water and sewage treatment works. However, this is not exactly comparable to the scope included in this case which is proactive condition driven process civils maintenance. The FAR analysis will also include:

- Proportional allocation to base of enhancement projects.
- Enabling civils for mechanical, electrical and instrumentation maintenance, e.g. a new kiosk for replacement SCADA.
- Minor reactive civils maintenance.
- Below ground civils maintenance (e.g. pipework between treatment stages) which could not have been identified by the method of the Atkins surveys.

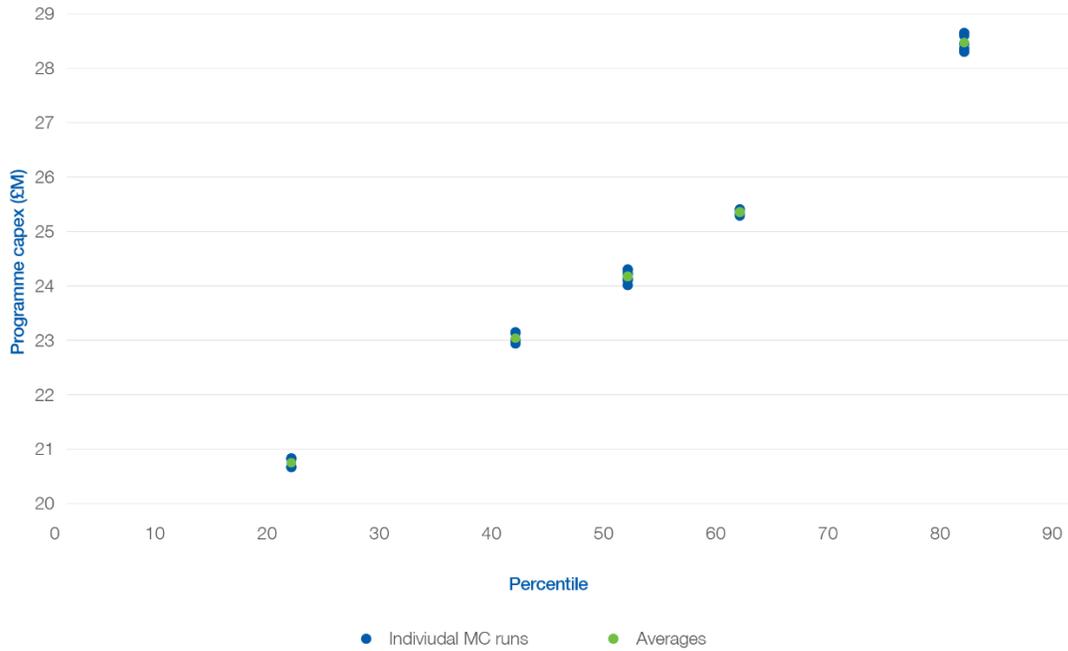
FIGURE 45: WTW CIVIL ASSET HEALTH PROGRAMME COST – 20% UNCERTAINTY

Figure 45 below shows the impact for water on programme cost of selecting different percentiles of output from the Monte Carlo analysis. We have selected the 50th percentile as we believe it provides the fairest share of risk with our customers.

⁴⁹ The spread of these 10 simulations was 1.2% from the lowest value £24.014m to a maximum of £24.305m.

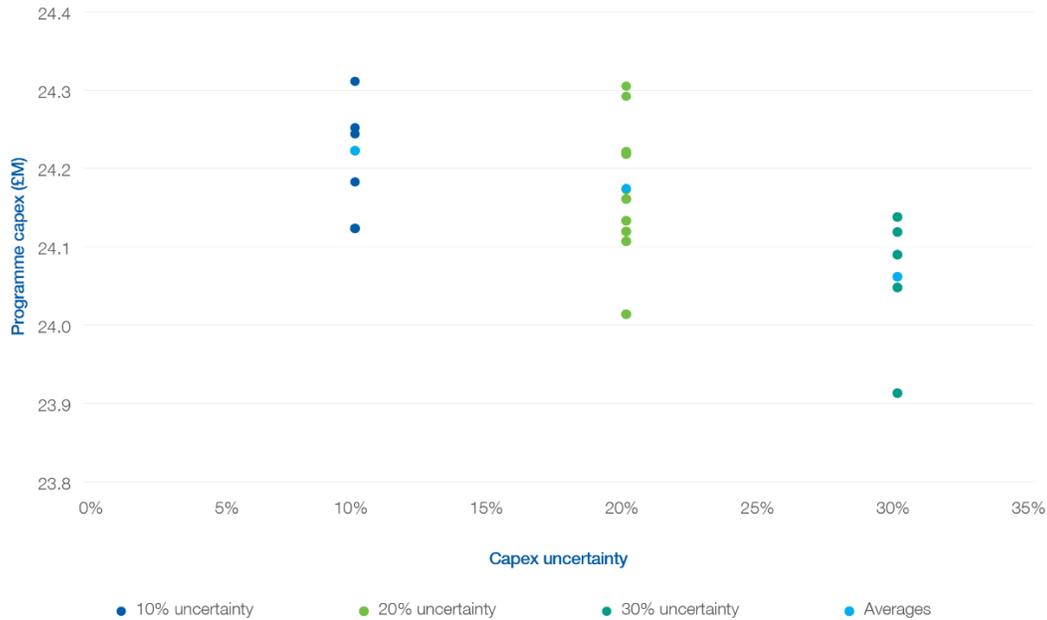
FIGURE 46: WTW CIVIL ASSET HEALTH PROGRAMME COST

We also performed a sensitivity test to demonstrate the impact of the assumption of uncertainty around the asset level cost estimates. We feel that 20% is the most appropriate choice given the costing methodology applied but the sensitivity test demonstrates that the impact of this assumption is not significant. The results of the sensitivity test are shown in Figure 46 below.

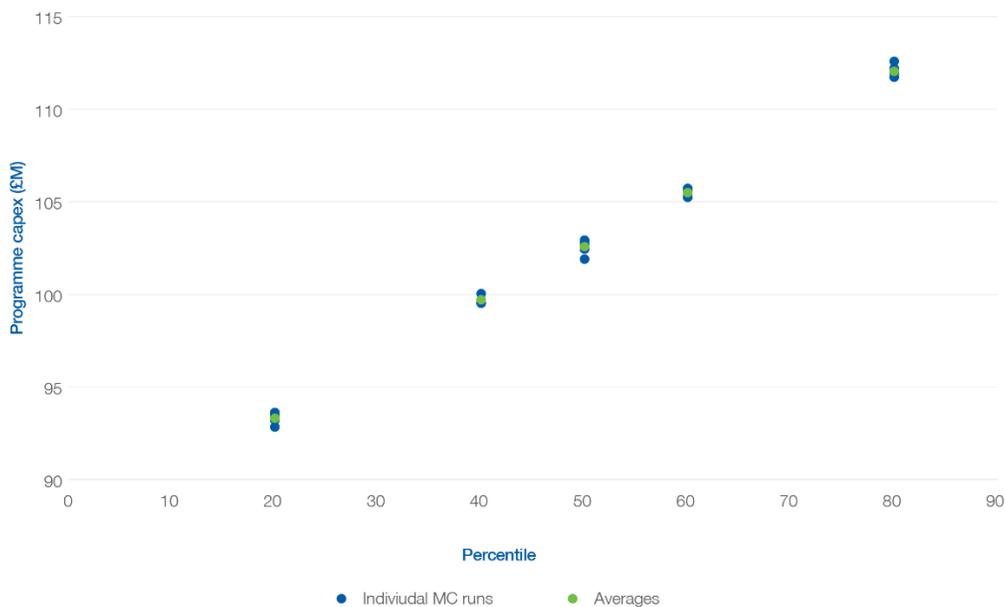
FIGURE 47: STW CIVIL ASSET HEALTH PROGRAMME COST – 20% UNCERTAINTY

Figure 47 below shows the impact for wastewater on programme cost of selecting different percentiles of output from the Monte Carlo analysis. We have selected the 50th percentile as we believe it provides the fairest share of risk with our customers. The analysis results in a 50th percentile programme capital cost of **£102.6m** to remediate the identified assets in poor condition and return them to a serviceable state (condition grade 2).

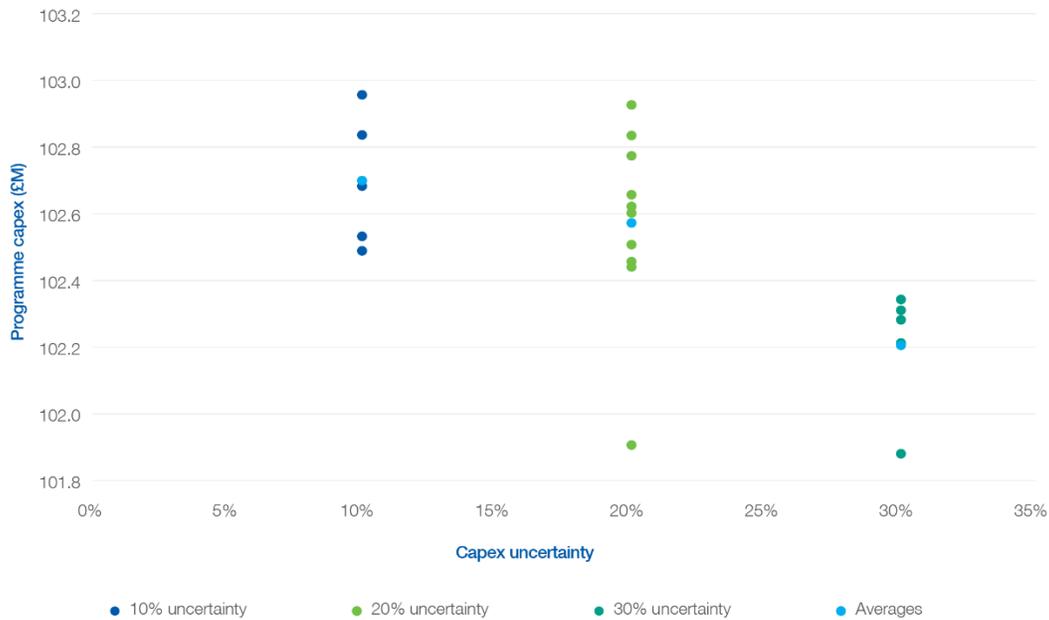
FIGURE 48: STW CIVIL ASSET HEALTH PROGRAMME COST

We also performed a sensitivity test to demonstrate the impact of the assumption of uncertainty around the asset level cost estimates. We feel that 20% is the most appropriate choice given the costing methodology applied but the sensitivity test demonstrates that the impact of this assumptions is not significant. The results of the sensitivity test are shown in Figure 48 below.

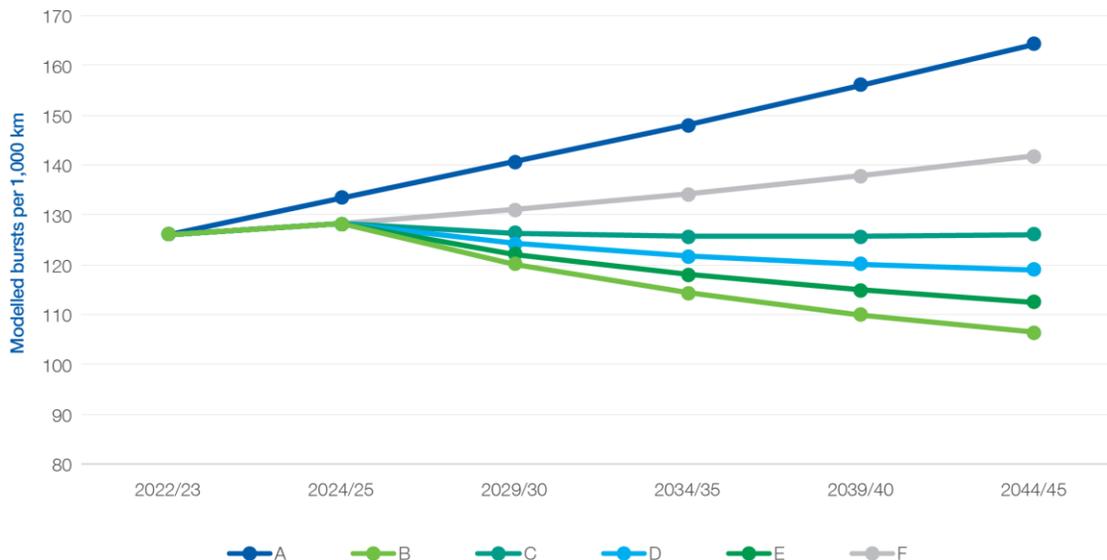
FIGURE 55: MODELLED BURST RISK IMPACT OF EACH OPTION

Option	Implied average asset age	Modelled burst risk/ 1000 km 2022/23	Modelled bursts/ 10000 km, 2029/30
A	-	126.03	140.62
B	588	126.03	130.95
C	270	126.03	126.37
D	213	126.03	124.21
E	175	126.03	122.11
F	149	126.03	120.08

Source: NWL analysis using performance and risk modelling tool

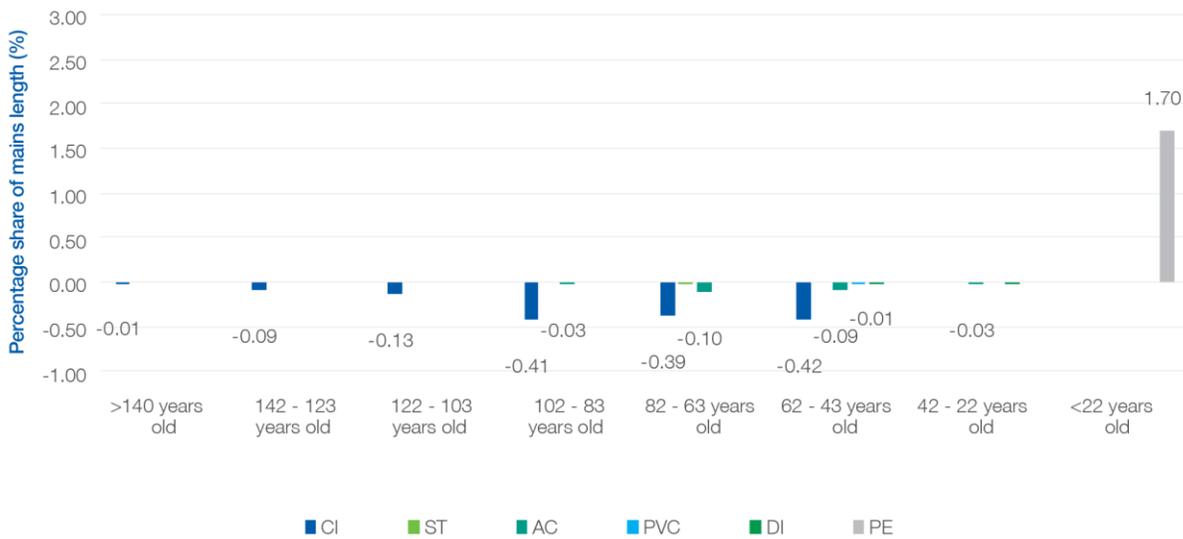
FIGURE 66: CHANGE IN MAINS MATERIAL AND AGE BANDS FROM OPTION B – RENEWING MAINS AT 0.17% P.A.

We have assessed the impact of Option C, our preferred option, on mains materials and age cohorts using the EDA model outputs, comparing it with Option B. Figure 6 and Figure 67 illustrate that our modelled renewal programmes for Options B and C respectively target mostly CI mains with the majority of them within an age band of 43-102 years old. They also show that the proportion of mains that are PE increases due to the renewal programme. Option C increasingly selects AC mains.

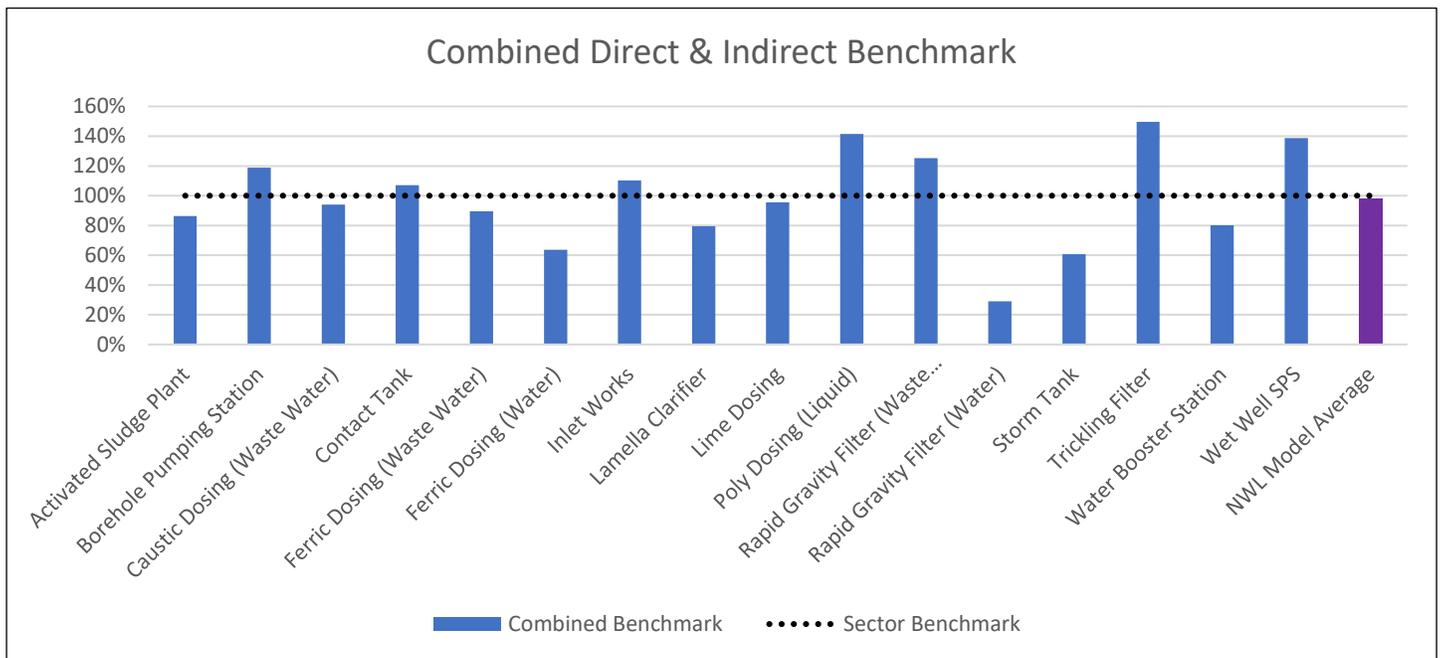
FIGURE 618: MM RESULTS OF PRE-ESTIMATION BENCHMARKING OF DIRECT AND INDIRECT COSTS

To benchmark the efficiency of the civil structures costs we have relied upon the “pre-estimation” benchmarking carried out by Mott Macdonald. This compared our cost curves used to estimate costs for capex schemes against the curves of other companies and also included benchmarking of indirect costs. The chart below summarises the overall finding from this work that our cost curves were 2% under the industry benchmark for comparable items.

Source: Mott Macdonald pre-estimation cost benchmarking
