PR24

NORTHUMBRIAN
WATER *living water*

A3-21 ASSET HEALTH INVESTMENT

NES35

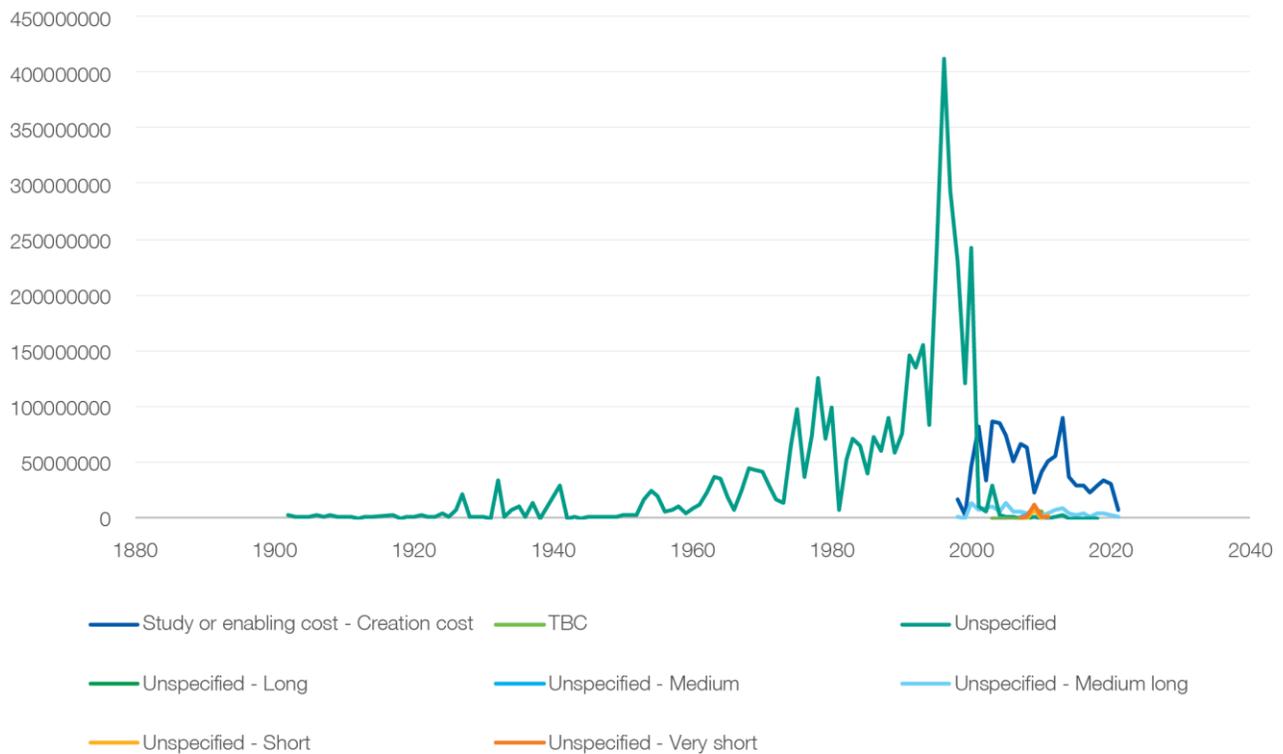
FIGURE 71: TOTAL FAR INFLATED VALUE BY YEAR BY CATEGORY

Figure 71 below shows the distribution of total value in each of these categories which require proportioning. The majority of unspecified costs (99%) were incurred before 2001, so are considered a legacy issue. Other categories, including those identifying studying and enabling costs and project overheads were only used from 1998. However, it was still important to identify the civils process assets within these categories, both for understanding historic investment and estimating future maintenance requirements.

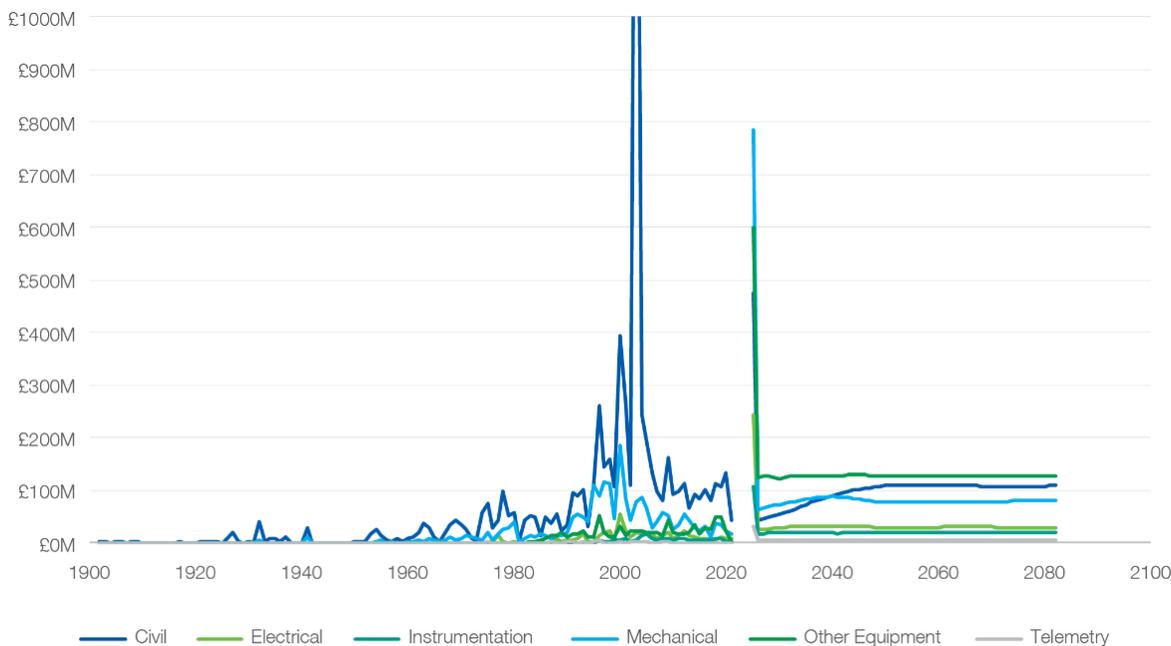
FIGURE 72: ALL FILTERED ASSETS – HISTORIC AND FUTURE INVESTMENT – 50% TRIANGULAR DISTRIBUTIONS

Triangular distributions to give an estimate of the range of possible failure ages are also a simplifying assumption, but again one that is applicable at a higher level. We carried out sensitivity analysis that looked at changing the spread of the triangular asset life distributions. The results can be seen in Figures 72 and 73 below.

If a much reduced triangular distribution spread is used, the result is a very similar backlog and average steady state future requirement. The estimated investment is just more variable year on year. The reality is likely to be more complex given individual asset operating conditions, maintenance etc, and the investment choices made. It was concluded the 50% distribution better represented these realities.

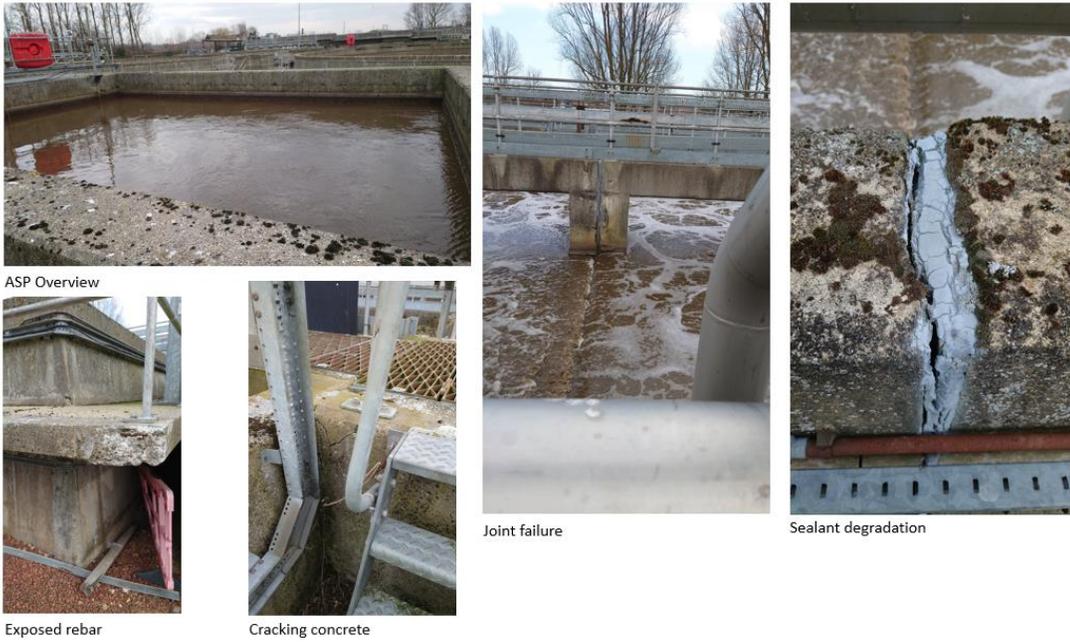
FIGURE 829: WORKSHOP MATERIALS TAKEN FROM SEDGELETCHE CONDITION SURVEY

The workshop utilised the following outputs as shown below and the visuals were taken from site as shown below in Figure 829:

“The cast in situ/buried concrete ASP tanks are in an average to poor condition. Significant spalling has occurred to the corner of the cantilever walkway resulting in the exposure of steel reinforcement. Sealant at the middle movement is in very poor condition and all other joints across the structure are in a poor condition and showing signs of degradation and is even missing in places. The movement joint has opened up significantly and requires further investigation. All handrailing is degrading and requires repainting.” (Taken from Condition Survey)
